**Flood Control Project Maintenance  
Levee Inspections**

**Fall 2013 Levee Maintenance Deficiency Summary Report**

**San Joaquin River Basin**

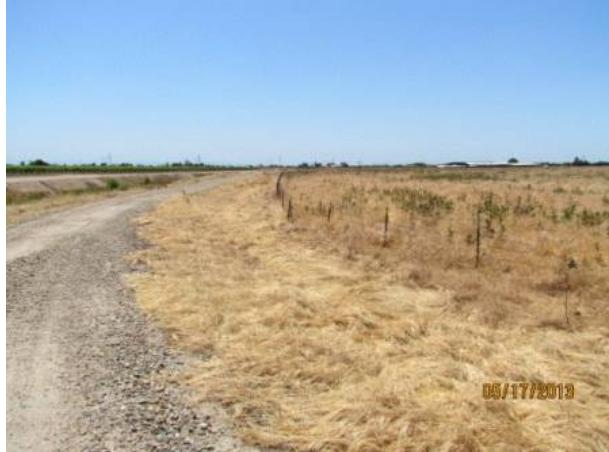
Levee Mile Report Line	9
Start Levee Mile	3.05
End Levee Mile	3.54
Location	Land Side
Category	Earthen Levee
Item	Encroachments
Fence was found on the landside slope of the levee looking downstream.	pkazi_f_20131001_212.JPG

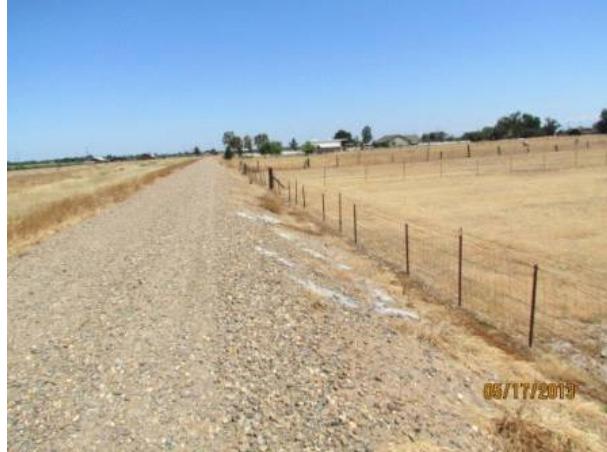
Levee Mile Report Line	1
Start Levee Mile	0.01
End Levee Mile	0.66
Location	Land Side
Category	Earthen Levee
Item	Encroachments
Fence was found on the landside toe of the levee looking upstream.	pkazi_f_20131001_223.JPG

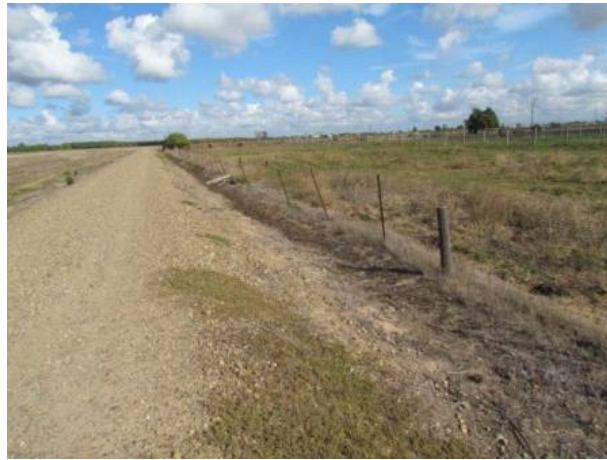
Levee Mile Report Line	3
Start Levee Mile	0.59
End Levee Mile	1.30
Location	Land Side
Category	Earthen Levee
Item	Encroachments
Fence was located on the landside toe of the levee looking upstream.	pkazi_f_20131001_224.jpg

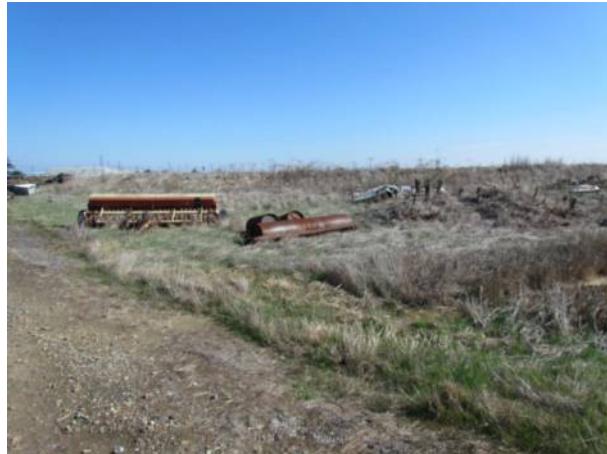
Levee Mile Report Line	6
Start Levee Mile	1.81
End Levee Mile	1.81
Location	Land Side
Category	Earthen Levee
Item	Encroachments
Equipment was found on the landside of the levee looking upstream.	
pkazi_f_20131001_234.jpg

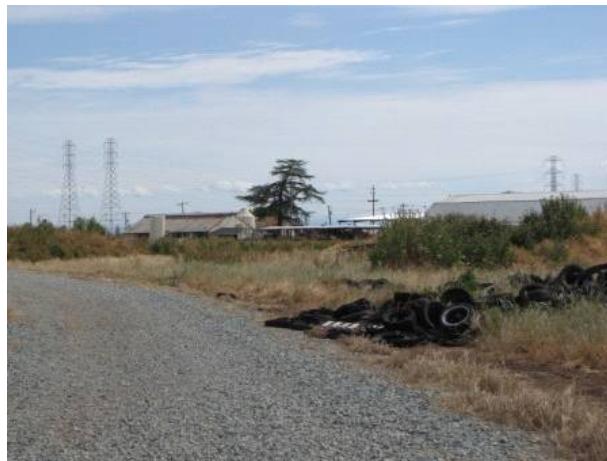
Levee Mile Report Line	7
Start Levee Mile	1.85
End Levee Mile	1.85
Location	Land Side
Category	Earthen Levee
Item	Encroachments
View of tires on the landward portion of the levee looking upstream.	
pkazi_f_20131001_230.jpg

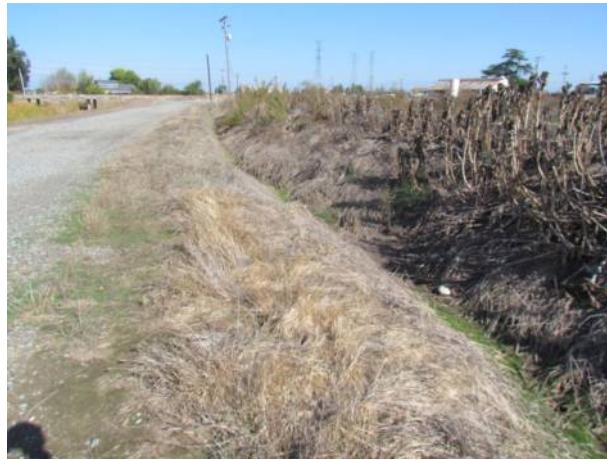
Levee Mile Report Line	8
Start Levee Mile	1.91
End Levee Mile	1.91
Location	Land Side
Category	Earthen Levee
Item	Encroachments
A ditch was located on the landside toe of the levee looking upstream.	
pkazi_f_20131001_235.jpg

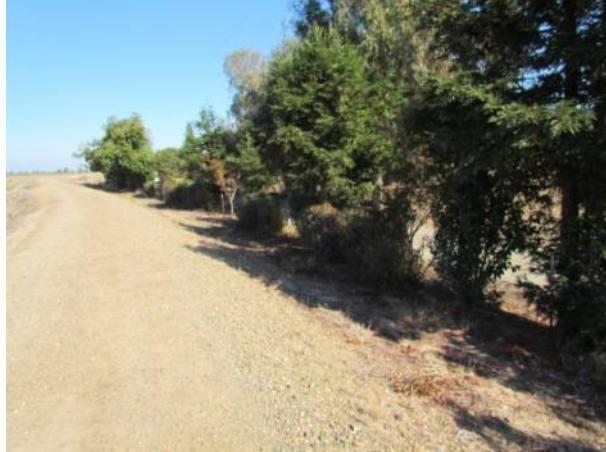
Levee Mile Report Line	9
Start Levee Mile	2.37
End Levee Mile	2.43
Location	Land Side
Category	Earthen Levee
Item	Vegetation
Trees and landscaping was found on the landside of the levee looking upstream.	
pkazi_f_20131001_225.jpg

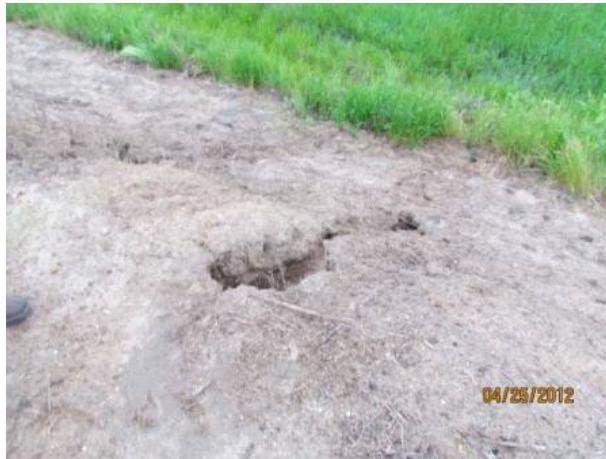
Levee Mile Report Line	10
Start Levee Mile	3.16
End Levee Mile	3.16
Location	Water Side
Category	Earthen Levee
Item	Erosion / Bank Caving
Erosion was found on the waterside of the levee looking downstream.	
pkazi_f_20131001_227.jpg

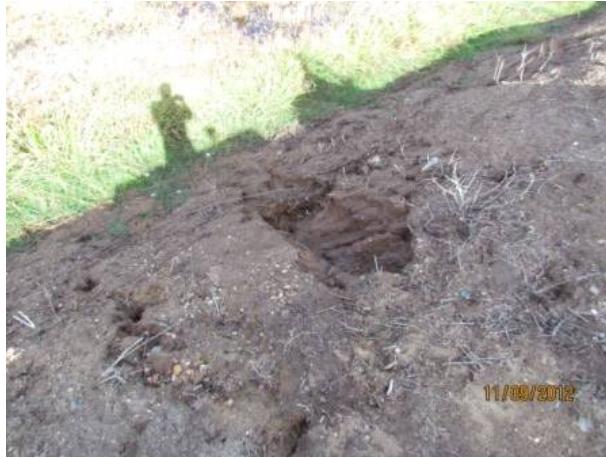
Levee Mile Report Line	11
Start Levee Mile	3.28
End Levee Mile	3.28
Location	Water Side
Category	Earthen Levee
Item	Slope Stability
Slope instability was found on the waterside slope of the levee looking upstream.	
pkazi_f_20131001_231.jpg

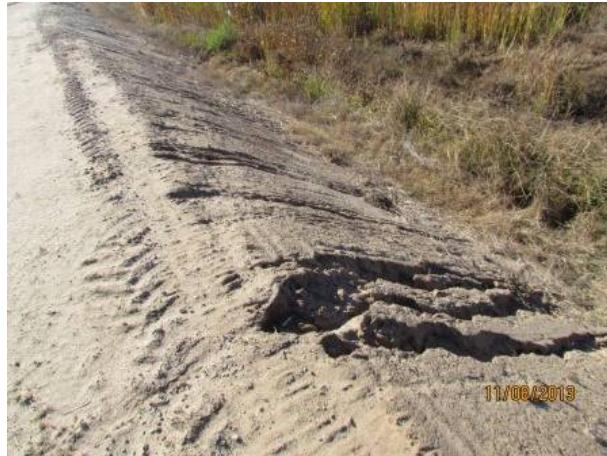
Levee Mile Report Line	11
Start Levee Mile	3.28
End Levee Mile	3.28
Location	Water Side
Category	Earthen Levee
Item	Slope Stability
Updated picture of the slope instability on the waterside of the levee. The picture was taken during fall 2013 inspection looking downstream.	
pkazi_f_20131111_038.JPG

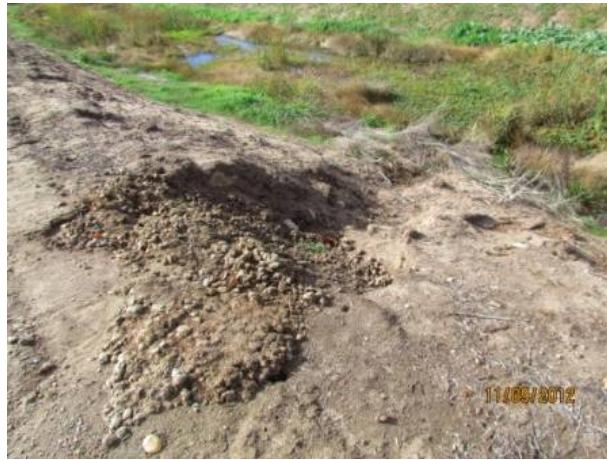
Levee Mile Report Line	14
Start Levee Mile	3.48
End Levee Mile	3.48
Location	Water Side
Category	Earthen Levee
Item	Erosion / Bank Caving
Erosion was found on the waterside slope of the levee looking downstream.	
pkazi_f_20131001_232.jpg

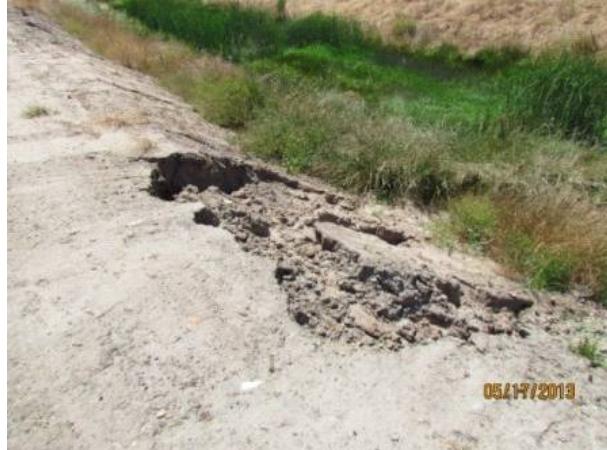
Levee Mile Report Line	14
Start Levee Mile	3.48
End Levee Mile	3.48
Location	Water Side
Category	Earthen Levee
Item	Erosion / Bank Caving
Updated picture of the erosion on the waterside slope of the levee looking downstream.	
pkazi_f_20131001_233.JPG

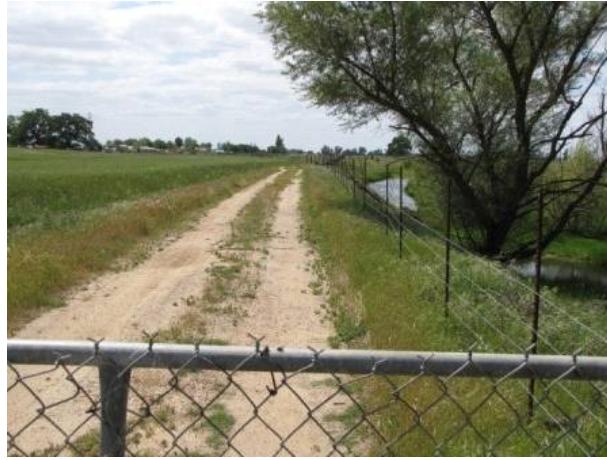
Levee Mile Report Line	16
Start Levee Mile	3.53
End Levee Mile	3.92
Location	Crown
Category	Earthen Levee
Item	Encroachments
Fence along waterward shoulder and crown of access road. The road cannot be driven through as the fence blocks access. The gate does not have a county key on the gate.	
pkazi_f_20131001_226.jpg

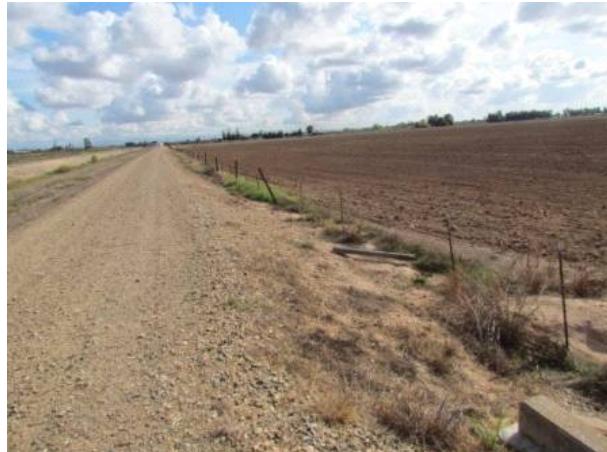
Levee Mile Report Line	1
Start Levee Mile	0.00
End Levee Mile	1.38
Location	Land Side
Category	Earthen Levee
Item	Encroachments
Fence was located on the landside of the levee looking upstream.	pkazi_f_20131001_238.jpg

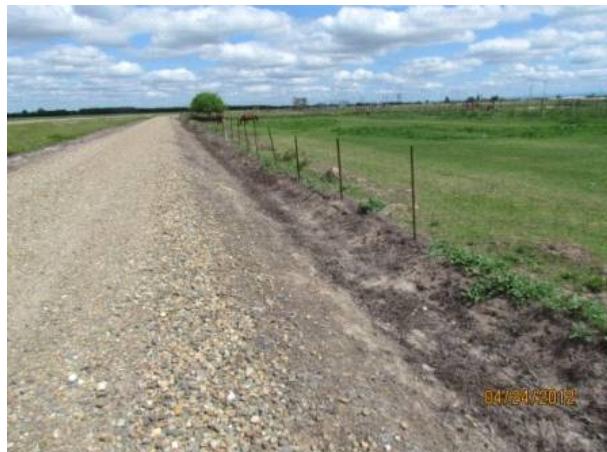
Levee Mile Report Line	1
Start Levee Mile	0.00
End Levee Mile	1.38
Location	Land Side
Category	Earthen Levee
Item	Encroachments
Fence was found on the landside of the levee looking upstream.	pkazi_f_20131001_239.jpg

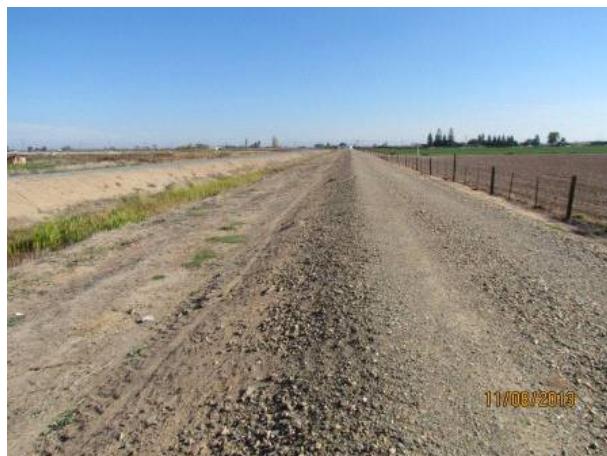
Levee Mile Report Line	2
Start Levee Mile	0.10
End Levee Mile	0.10
Location	Water Side
Category	Earthen Levee
Item	Vegetation
View of the waterside of the levee looking upstream.	pkazi_f_20131111_039.JPG

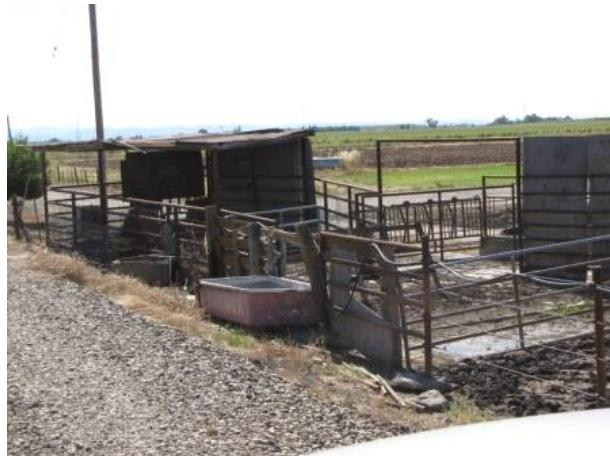
Levee Mile Report Line	3
Start Levee Mile	0.39
End Levee Mile	0.39
Location	Land Side
Category	Earthen Levee
Item	Encroachments
View of a tub/tank on the landward slope blocking access and visibility looking upstream.	
pkazi_f_20131001_237.jpg

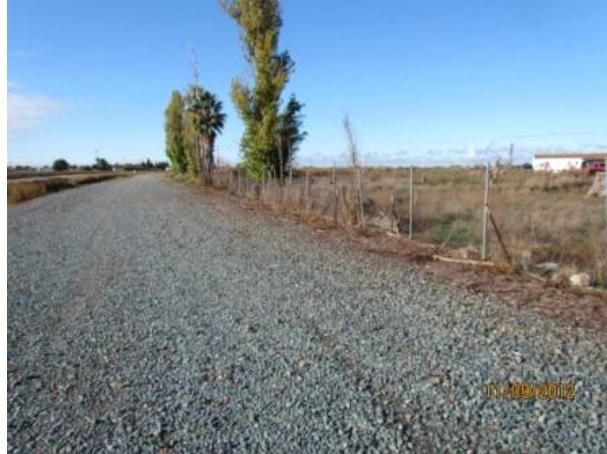
Levee Mile Report Line	1
Start Levee Mile	0.02
End Levee Mile	0.55
Location	Land Side
Category	Earthen Levee
Item	Encroachments
Fence was found on the landside of the levee looking downstream.	pkazi_f_20131001_246.jpg

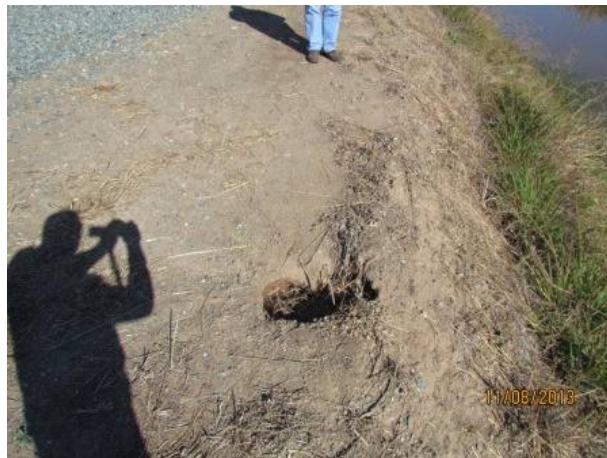
Levee Mile Report Line	2
Start Levee Mile	0.43
End Levee Mile	0.43
Location	Water Side
Category	Earthen Levee
Item	Animal Control
View of a rodent hole on the waterside shoulder of the levee looking upstream.	pkazi_f_20131111_040.JPG

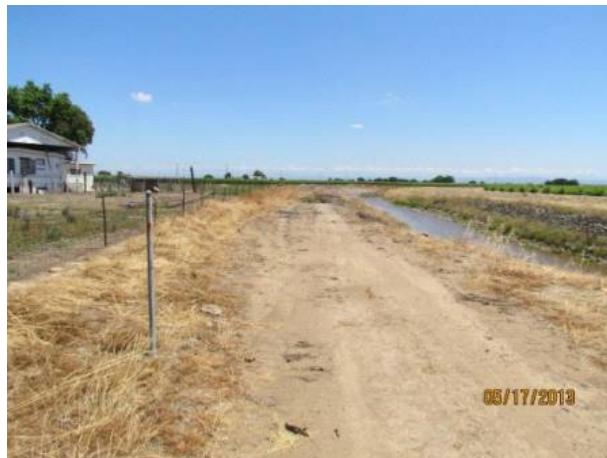
Levee Mile Report Line	3
Start Levee Mile	0.57
End Levee Mile	0.57
Location	Crown
Category	Earthen Levee
Item	Crown Surface / Depressions / Rutting
Crown depression was found looking upstream.	pkazi_f_20131001_247.JPG

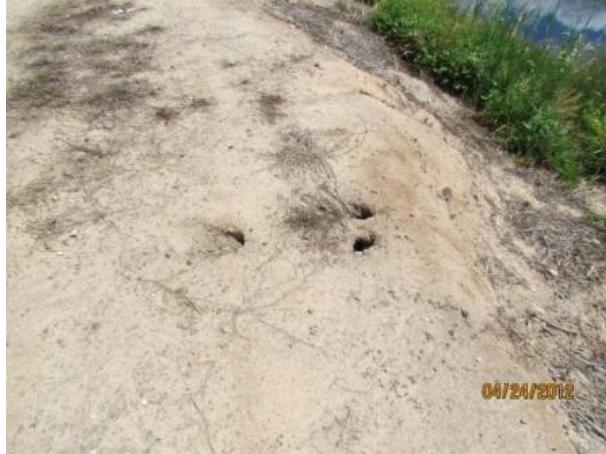
Levee Mile Report Line	4
Start Levee Mile	0.61
End Levee Mile	0.61
Location	Water Side
Category	Earthen Levee
Item	Animal Control
Animal holes were found on the waterside of the levee looking upstream.	
pkazi_f_20131001_245.jpg

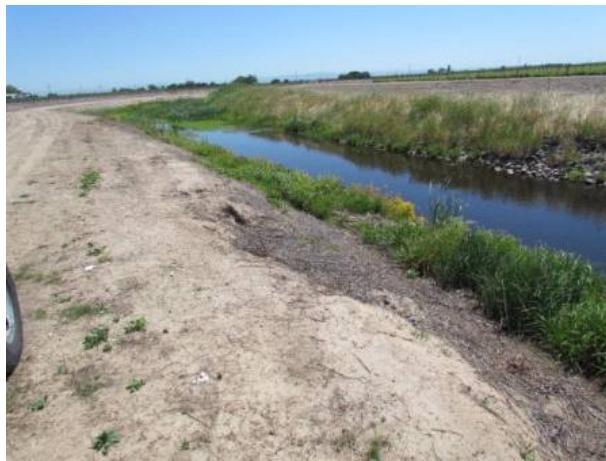
Levee Mile Report Line	5
Start Levee Mile	0.61
End Levee Mile	0.61
Location	Water Side
Category	Earthen Levee
Item	Erosion / Bank Caving
Erosion was found on the waterside of the levee.	
pkazi_f_20131001_243.jpg

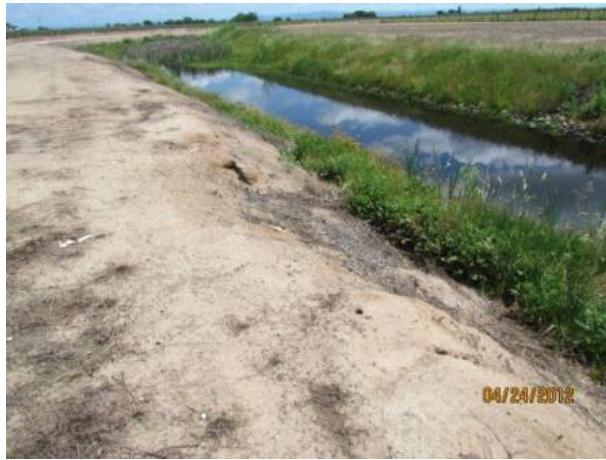
Levee Mile Report Line	5
Start Levee Mile	0.61
End Levee Mile	0.61
Location	Water Side
Category	Earthen Levee
Item	Erosion / Bank Caving
Erosion was found on the waterside of the levee looking upstream. This picture was taken during spring 2012 inspection.	
pkazi_f_20131001_244.jpg

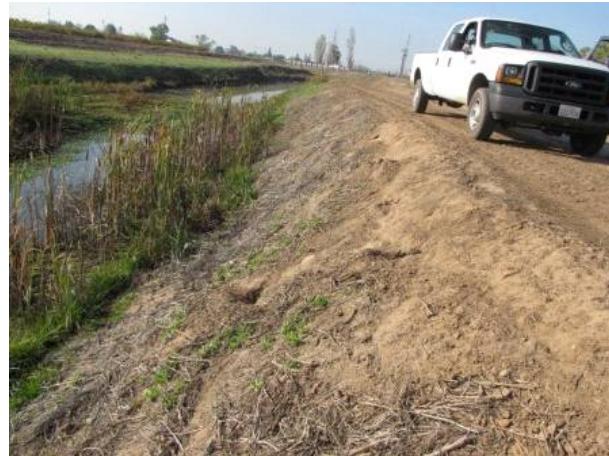
Levee Mile Report Line	6
Start Levee Mile	0.65
End Levee Mile	0.65
Location	Water Side
Category	Earthen Levee
Item	Animal Control
View of rodent holes in the waterward berm looking downstream.	
<i>pkazi_f_20131001_240.jpg</i>

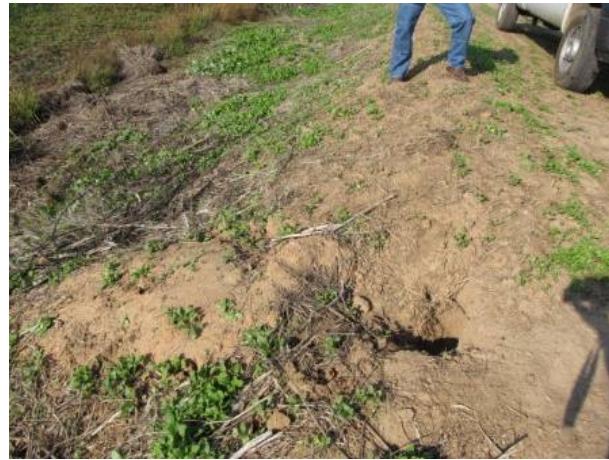
Levee Mile Report Line	8
Start Levee Mile	0.83
End Levee Mile	0.83
Location	Water Side
Category	Earthen Levee
Item	Animal Control
View of a large diameter rodent hole in the waterward berm looking downstream.	
<i>pkazi_f_20131001_241.jpg</i>

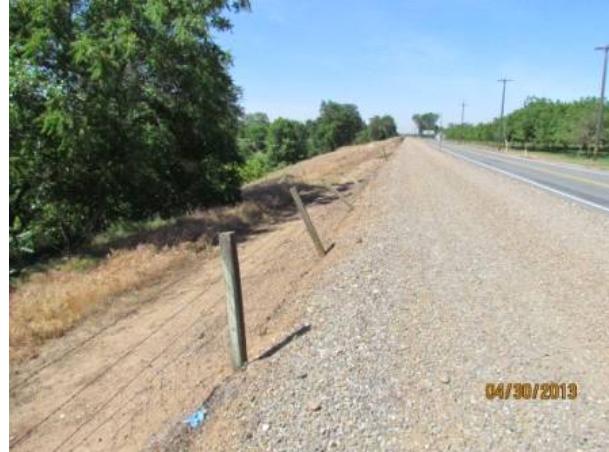
Levee Mile Report Line	3
Start Levee Mile	0.37
End Levee Mile	0.64
Location	Water Side
Category	Earthen Levee
Item	Encroachments
Fences were found on the waterside shoulder of the levee looking downstream.	
pkazi_f_20131001_248.JPG

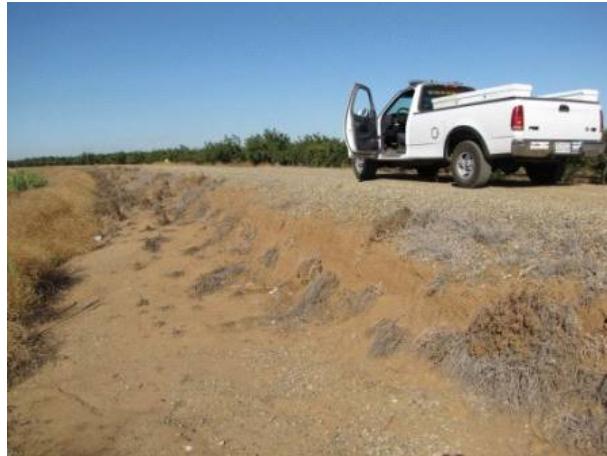
Levee Mile Report Line	8
Start Levee Mile	1.52
End Levee Mile	1.52
Location	Water Side
Category	Earthen Levee
Item	Erosion / Bank Caving
View of erosion of waterward levee slope looking upstream.	
pkazi_f_20131001_372.jpg

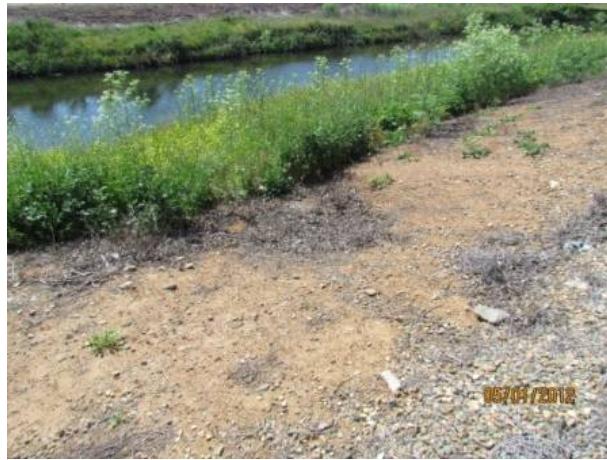
Levee Mile Report Line	11
Start Levee Mile	2.09
End Levee Mile	2.09
Location	Water Side
Category	Earthen Levee
Item	Slope Stability
Slope instability was found on the waterside toe of the levee looking downstream.	
pkazi_f_20131001_260.jpg

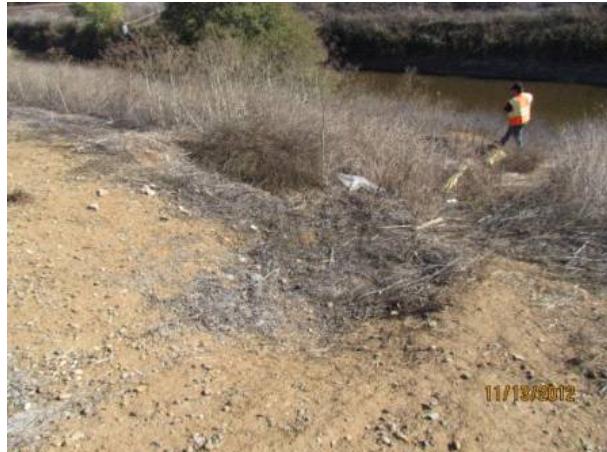
Levee Mile Report Line	11
Start Levee Mile	2.09
End Levee Mile	2.09
Location	Water Side
Category	Earthen Levee
Item	Slope Stability
Updated picture of the slope instability at the waterside slope of the levee looking upstream.	
pkazi_f_20131001_261.jpg

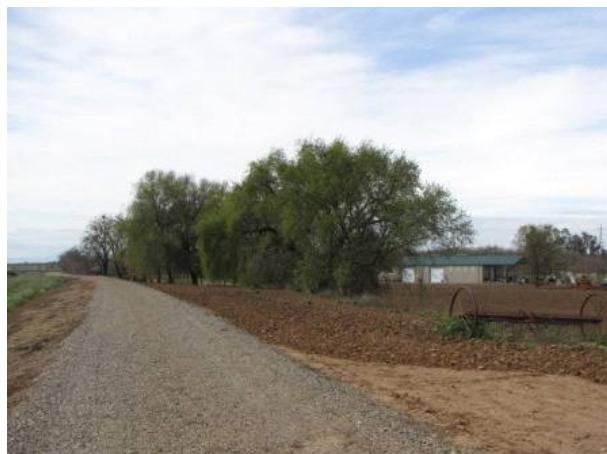
Levee Mile Report Line	12
Start Levee Mile	2.42
End Levee Mile	2.57
Location	Land Side
Category	Earthen Levee
Item	Encroachments
View of the landward shoulder where a landowner has disced the levee looking downstream.	
pkazi_f_20131001_277.jpg

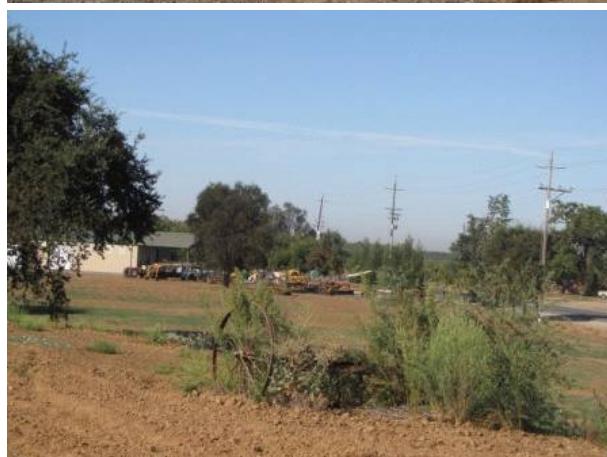
Levee Mile Report Line	13
Start Levee Mile	2.43
End Levee Mile	2.43
Location	Land Side
Category	Earthen Levee
Item	Encroachments
View of equipment on the landward slope of the levee looking downstream.	
pkazi_f_20131001_276.jpg

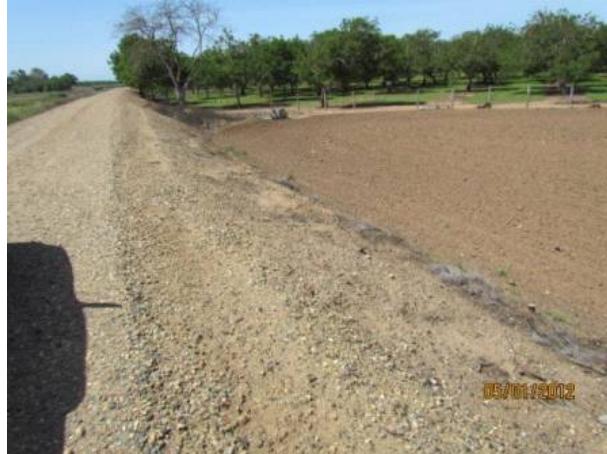
Levee Mile Report Line	14
Start Levee Mile	2.59
End Levee Mile	2.59
Location	Land Side
Category	Earthen Levee
Item	Slope Stability
Slope instability was found on the landside slope of the levee looking downstream.	
pkazi_f_20131001_290.jpg

DWR ID: DWR_NA0017_15_s_2012_35	
14	2.59	2.59	Earthen Levee	Slope Stability	LS	M	S1 : Repair slope instability. Ma	38.031234 °	38.031234 °	47	-121.047254 °	-121.047254 °	Y
												DWR ID: DWR_NA0017_15_s_2012_47	
15	2.68	2.68	Earthen Levee	Slope Stability	LS	M	S1 : Repair slope instability. Ma	38.030252 °	38.030252 °	27	-121.048311 °	-121.048311 °	Y
												DWR ID: DWR_NA0017_15_s_2012_27	
16	2.68	2.71	Earthen Levee	Encroachments	LS	M	BU : Building En Inspector Comments: Retaining wall at toe of slope & irrigation recently placed.	38.030173 °	38.029949 °	66	-121.048432 °	-121.048732 °	Y
												DWR ID: DWR_NA0017_15_s_2012_66	
17	2.73	2.73	Earthen Levee	Vegetation	LS	M	V6 : Landscaping En	38.030185 °	38.030185 °	3	-121.049397 °	-121.049397 °	Y
												DWR ID: DWR_NA0017_15_s_2012_3	
18	2.74	2.75	Earthen Levee	Encroachments	LS	M	BU : Building En Inspector Comments: Retaining wall at landside toe of levee.	38.029641 °	38.029505 °	959	-121.049165 °	-121.049372 °	Y

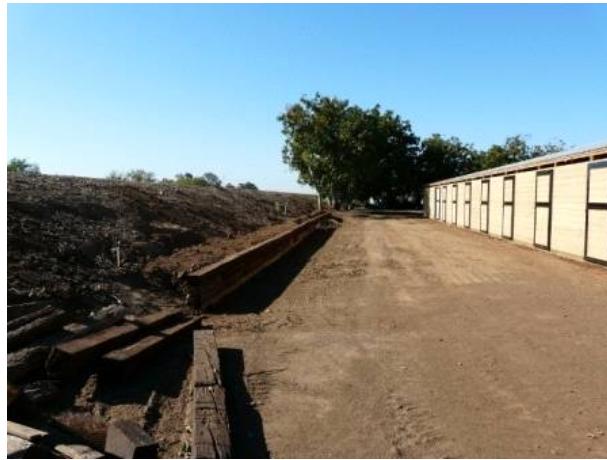
Levee Mile Report Line	16
Start Levee Mile	2.68
End Levee Mile	2.71
Location	Land Side
Category	Earthen Levee
Item	Encroachments
Recently built retaining wall at toe of landside levee at LM 2.68.	
pkazi_f_20131001_304.JPG

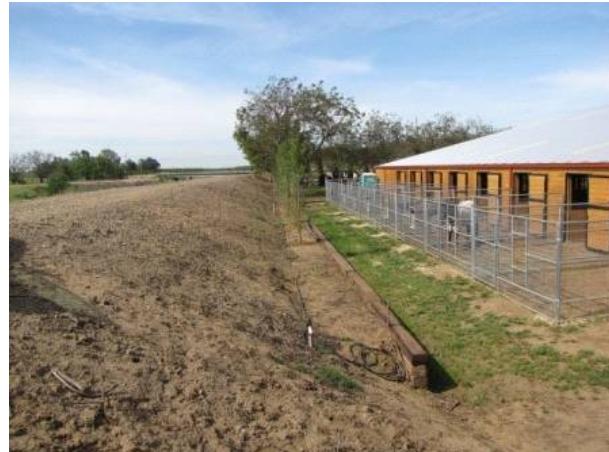
Levee Mile Report Line	16
Start Levee Mile	2.68
End Levee Mile	2.71
Location	Land Side
Category	Earthen Levee
Item	Encroachments
Updated view as of spring 2009. Landscaping and irrigation have been added at the toe of the levee.	
pkazi_f_20131001_305.jpg

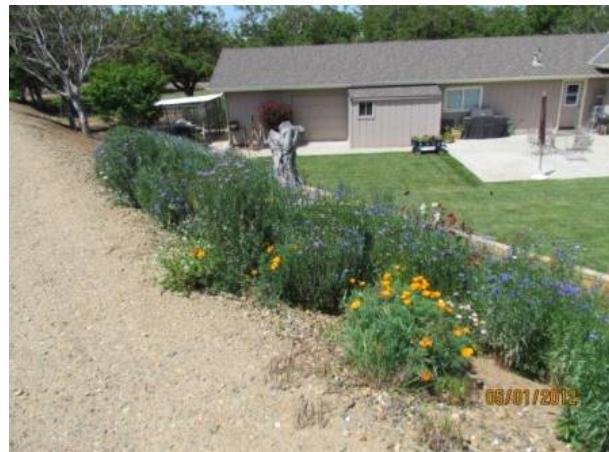
Levee Mile Report Line	17
Start Levee Mile	2.73
End Levee Mile	2.73
Location	Land Side
Category	Earthen Levee
Item	Vegetation
Landscape was found on the landside of the levee looking downstream.	
pkazi_f_20131001_250.jpg

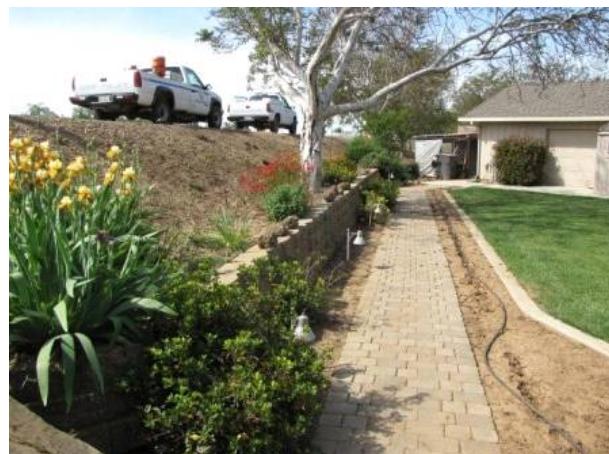
Levee Mile Report Line	18
Start Levee Mile	2.74
End Levee Mile	2.75
Location	Land Side
Category	Earthen Levee
Item	Encroachments
View of retaining wall and landscaping along the landward toe of the levee.	
pkazi_f_20131001_369.jpg

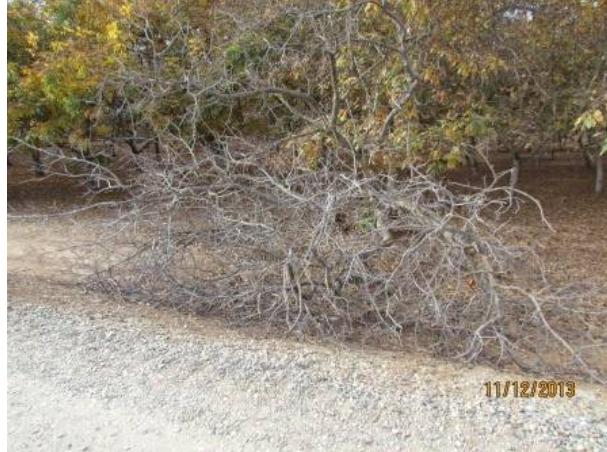
Levee Mile Report Line	19
Start Levee Mile	3.08
End Levee Mile	3.08
Location	Land Side
Category	Earthen Levee
Item	Encroachments
Pruning was found on the landside of the levee looking downstream.	
pkazi_f_20131118_048.JPG

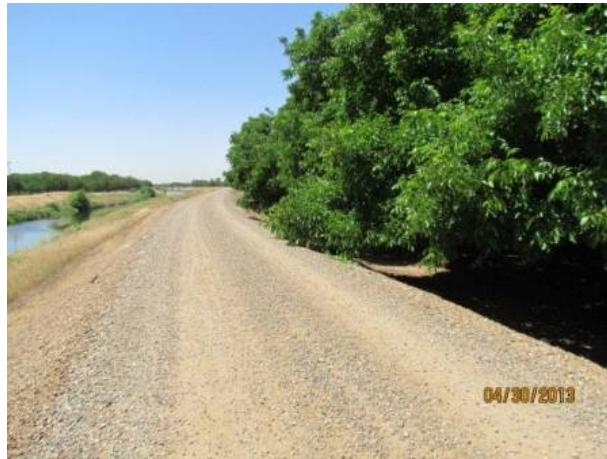
Levee Mile Report Line	22
Start Levee Mile	3.22
End Levee Mile	3.22
Location	Land Side
Category	Earthen Levee
Item	Trim / Thin Trees
Tree limbs were obstructing visibility on the landside slope of the levee looking downstream.	
pkazi_f_20131001_255.JPG

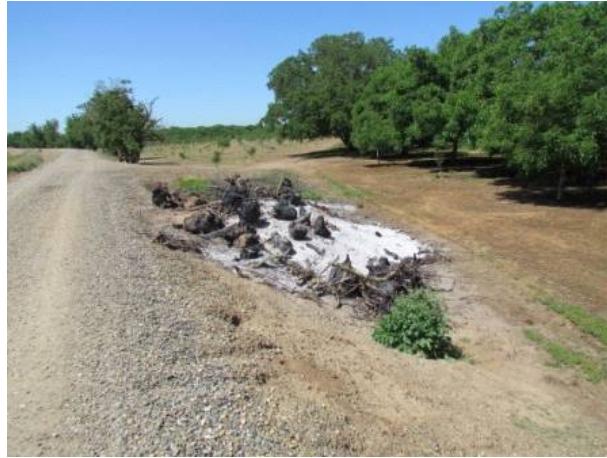
Levee Mile Report Line	23
Start Levee Mile	3.40
End Levee Mile	3.40
Location	Land Side
Category	Earthen Levee
Item	Encroachments
Burn pile and new material was placed at the toe of the landside of the levee. The picture was taken from the crown looking downstream.	
pkazi_f_20131001_256.jpg

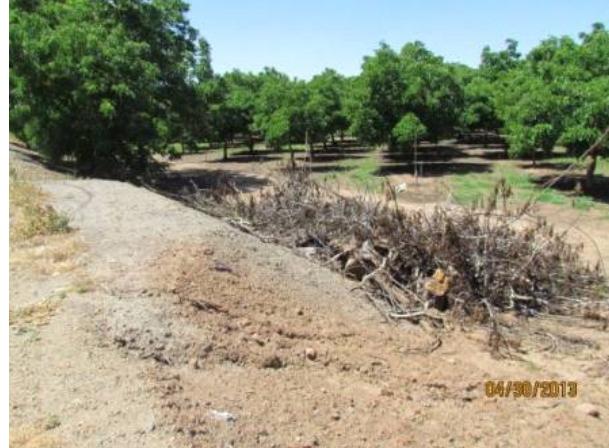
Levee Mile Report Line	25
Start Levee Mile	3.61
End Levee Mile	3.61
Location	Land Side
Category	Earthen Levee
Item	Encroachments
Prunings were found on the landside toe of the levee looking downstream.	
pkazi_f_20131001_258.JPG

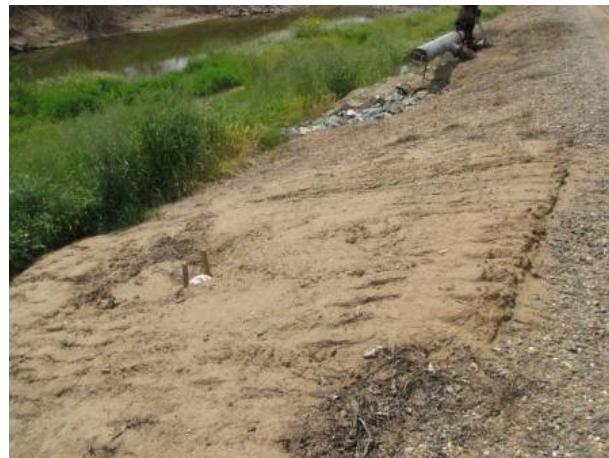
Levee Mile Report Line	26
Start Levee Mile	3.62
End Levee Mile	3.62
Location	Water Side
Category	Earthen Levee
Item	Encroachments
View of a recently place pipe in the waterward slope looking downstream.	
pkazi_f_20131001_295.jpg

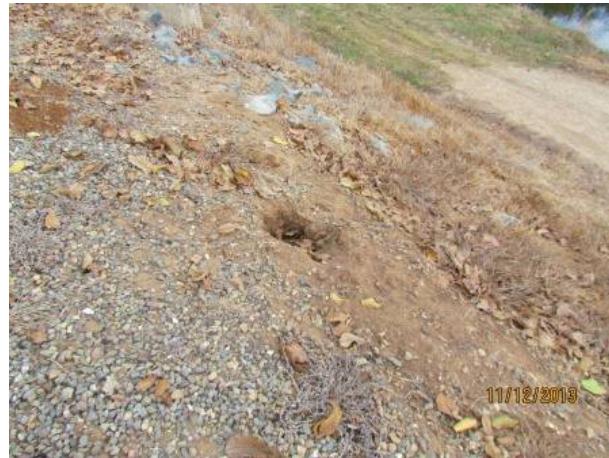
Levee Mile Report Line	27
Start Levee Mile	3.64
End Levee Mile	3.64
Location	Water Side
Category	Earthen Levee
Item	Animal Control
An animal hole was found on the waterside slope of the levee looking upstream.	
pkazi_f_20131118_049.JPG

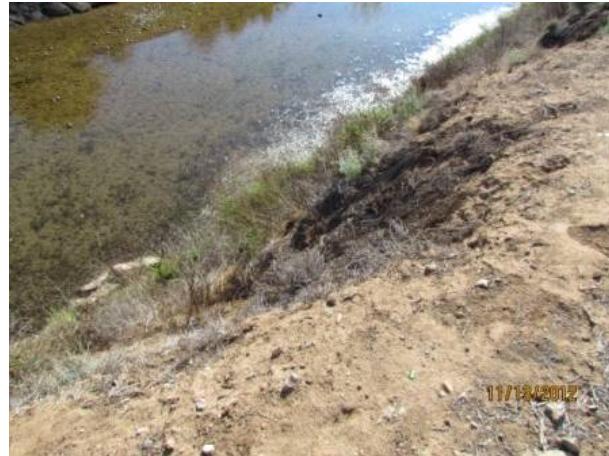
Levee Mile Report Line	28
Start Levee Mile	3.81
End Levee Mile	3.81
Location	Water Side
Category	Earthen Levee
Item	Erosion / Bank Caving
Erosion was found on the waterside slope of the levee looking downstream.	
pkazi_f_20131001_283.jpg

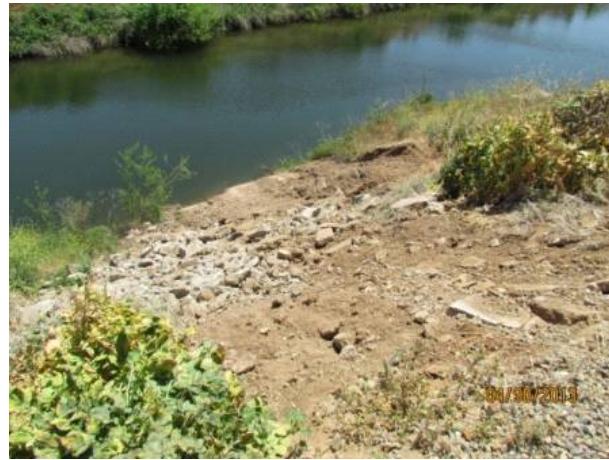
Levee Mile Report Line	29
Start Levee Mile	3.86
End Levee Mile	3.86
Location	Water Side
Category	Earthen Levee
Item	Slope Stability
Updated picture of the slope instability on the waterside slope of the levee looking downstream.	
pkazi_f_20131001_285.JPG

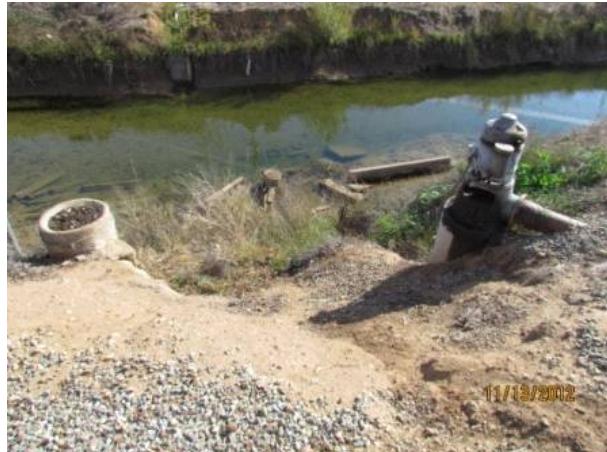
Levee Mile Report Line	31
Start Levee Mile	3.97
End Levee Mile	3.97
Location	Water Side
Category	Earthen Levee
Item	Slope Stability
Slope instability was found on the landside slope of the levee looking downstream.	
pkazi_f_20131001_286.jpg

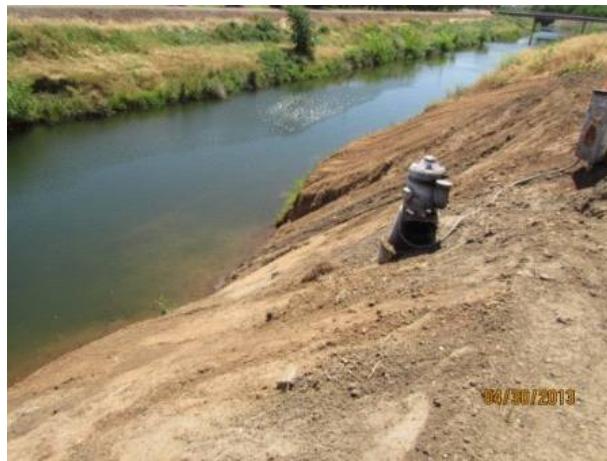
Levee Mile Report Line	31
Start Levee Mile	3.97
End Levee Mile	3.97
Location	Water Side
Category	Earthen Levee
Item	Slope Stability
Updated picture of the slope instability on the waterside slope of the levee looking downstream.	
pkazi_f_20131001_287.JPG

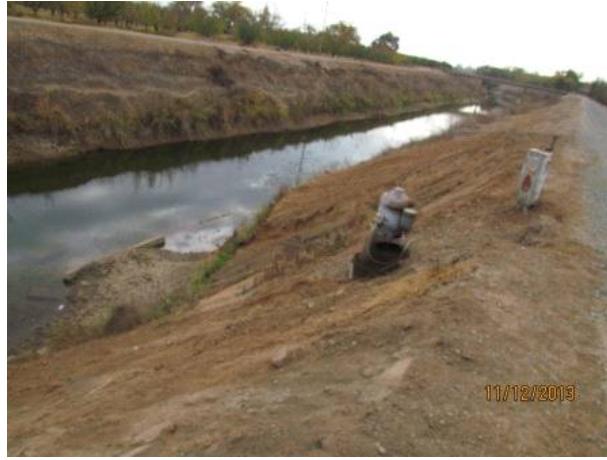
Levee Mile Report Line	31
Start Levee Mile	3.97
End Levee Mile	3.97
Location	Water Side
Category	Earthen Levee
Item	Slope Stability
Updated picture of the slope instability on the waterside slope of the levee looking downstream during fall 2013 inspection.	
pkazi_f_20131118_050.JPG

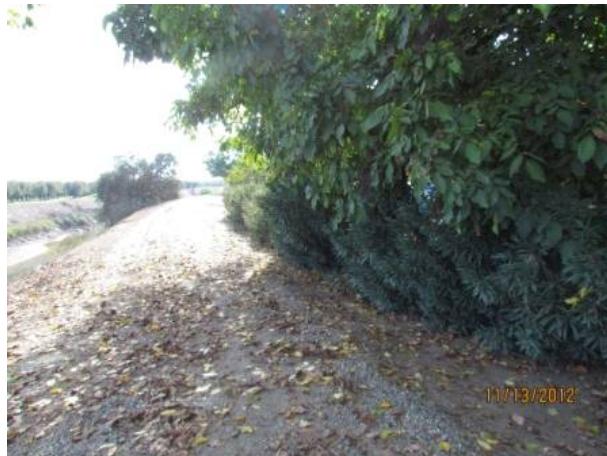
Levee Mile Report Line	32
Start Levee Mile	4.13
End Levee Mile	4.15
Location	Land Side
Category	Earthen Levee
Item	Vegetation
Landscape was blocking the visibility on the landside of the levee looking downstream.	
pkazi_f_20131001_259.jpg

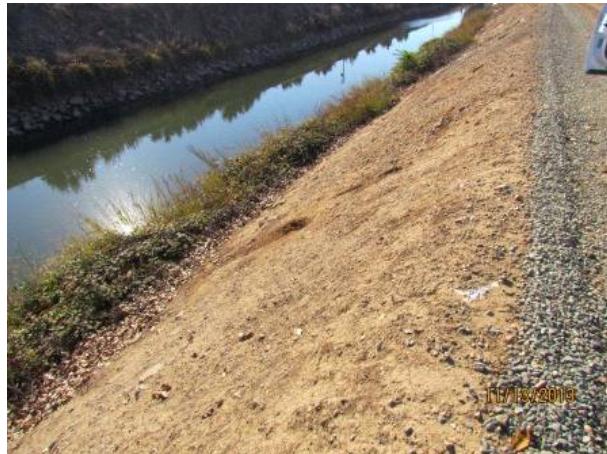
Levee Mile Report Line	33
Start Levee Mile	4.21
End Levee Mile	4.21
Location	Water Side
Category	Earthen Levee
Item	Animal Control
An animal hole was found on the waterside slope of the levee looking downstream.	
pkazi_f_20131118_051.JPG

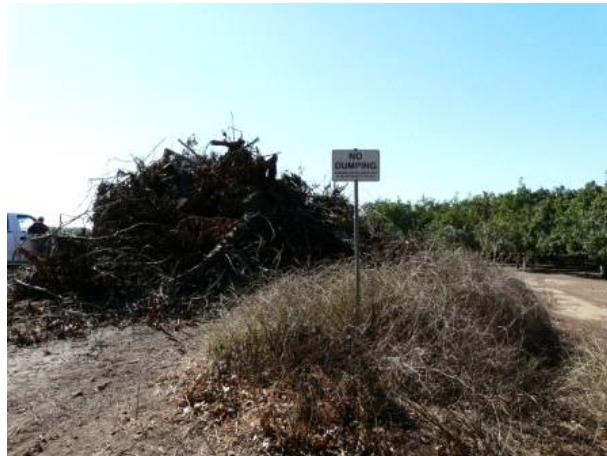
Levee Mile Report Line	34
Start Levee Mile	4.29
End Levee Mile	4.29
Location	Land Side
Category	Earthen Levee
Item	Encroachments
Example of a prunings pile immediately adjacent to access road at LM 4.29. Evidence of habitual burnings at this site.	
pkazi_f_20131001_262.JPG

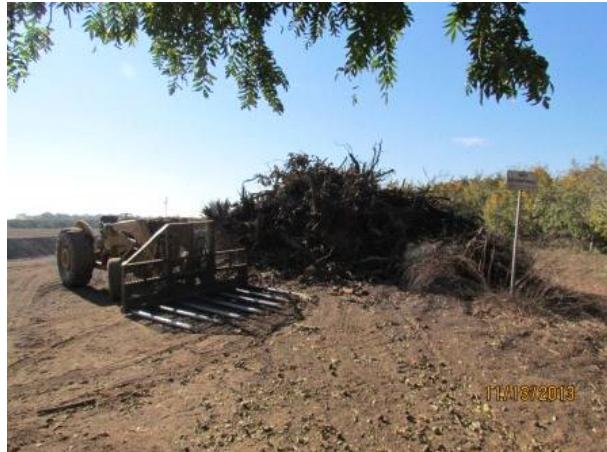
Levee Mile Report Line	34
Start Levee Mile	4.29
End Levee Mile	4.29
Location	Land Side
Category	Earthen Levee
Item	Encroachments
Updated picture of the prunings pile on the landside of the levee looking downstream during fall 2013 inspection.	
pkazi_f_20131118_052.JPG

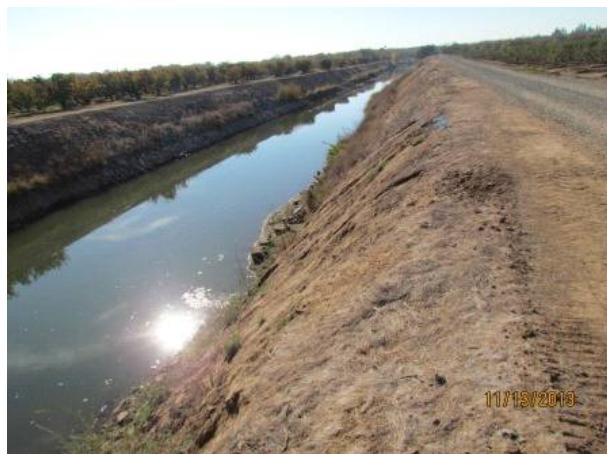
Levee Mile Report Line	35
Start Levee Mile	4.41
End Levee Mile	4.41
Location	Water Side
Category	Earthen Levee
Item	Slope Stability
Slope instability was found on the waterside slope of the levee looking downstream.	
pkazi_f_20131119_053.JPG

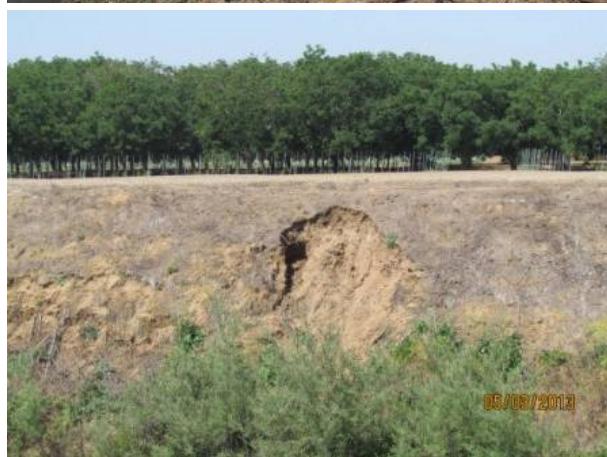
Levee Mile Report Line	37
Start Levee Mile	4.44
End Levee Mile	4.44
Location	Water Side
Category	Earthen Levee
Item	Animal Control
An animal hole was found on the waterside slope of the levee. The picture was taken from the opposite side of the levee.	
pkazi_f_20131001_347.JPG

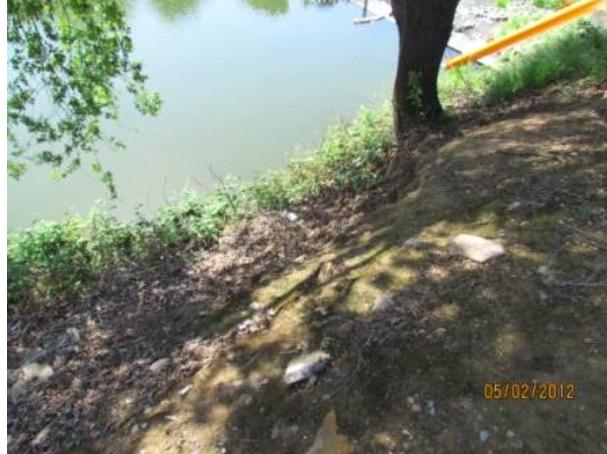
Levee Mile Report Line	39
Start Levee Mile	4.73
End Levee Mile	4.73
Location	Water Side
Category	Earthen Levee
Item	Erosion / Bank Caving
Erosion was found on the waterside slope of the levee looking downstream.	
pkazi_f_20131001_325.jpg

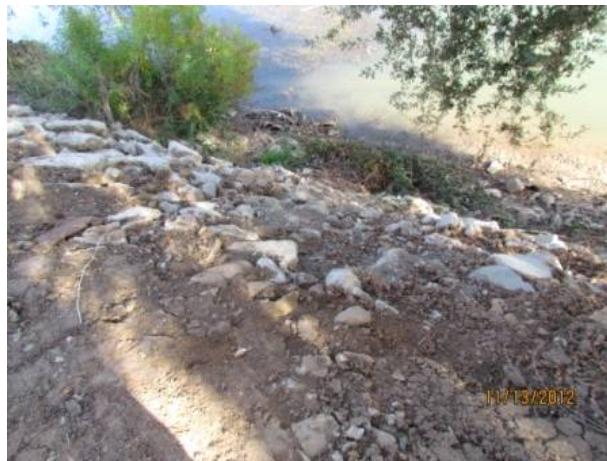
Levee Mile Report Line	39
Start Levee Mile	4.73
End Levee Mile	4.73
Location	Water Side
Category	Earthen Levee
Item	Erosion / Bank Caving
The LMA has fixed the erosion on the landside slope of the levee but the riprap contains exposed rebar which could be dangerous during a flood fight.	
pkazi_f_20131001_326.jpg

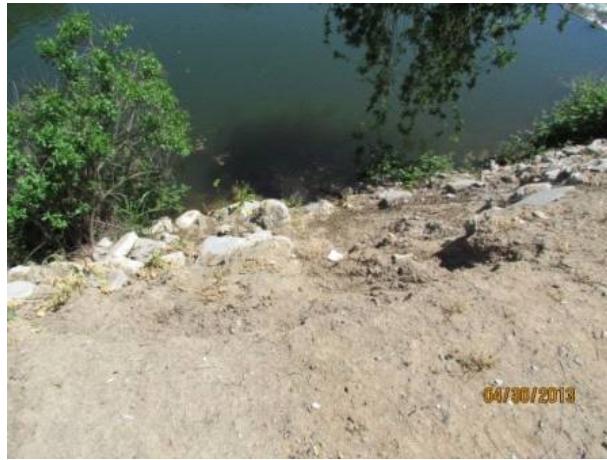
Levee Mile Report Line	39
Start Levee Mile	4.73
End Levee Mile	4.73
Location	Water Side
Category	Earthen Levee
Item	Erosion / Bank Caving
Updated picture of the slope instability on the waterside slope of the levee looking downstream during spring 2013 inspection.	
pkazi_f_20131001_327.JPG

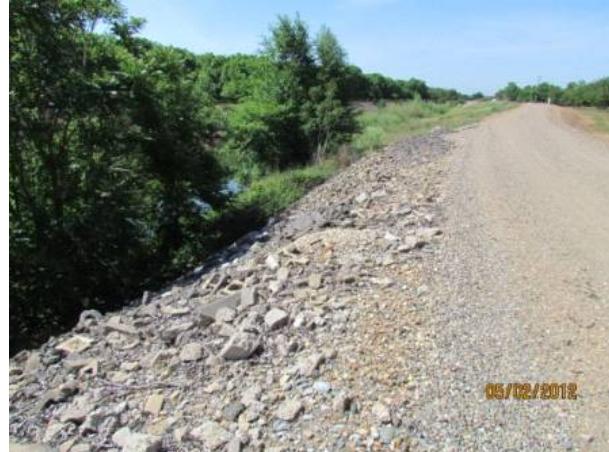
Levee Mile Report Line	40
Start Levee Mile	4.80
End Levee Mile	4.80
Location	Water Side
Category	Earthen Levee
Item	Encroachments
Debris was found on the waterside of the levee looking downstream.	
pkazi_f_20131001_329.jpg

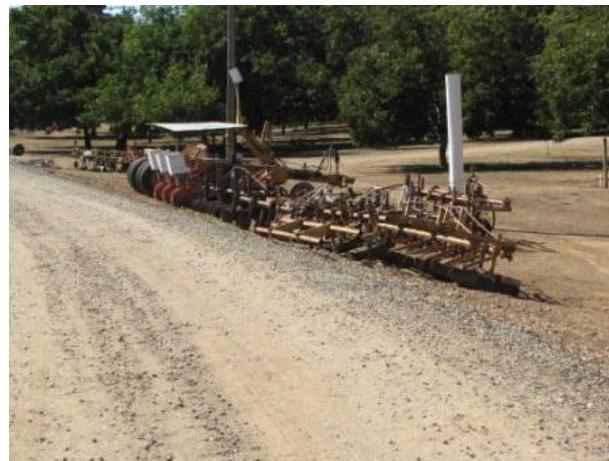
Levee Mile Report Line	41
Start Levee Mile	4.96
End Levee Mile	4.96
Location	Land Side
Category	Earthen Levee
Item	Encroachments
View of equipment along the landward slope looking downstream.	
pkazi_f_20131001_263.jpg

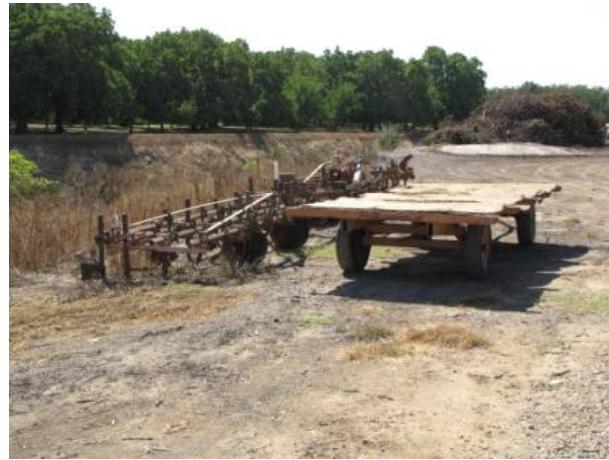
Levee Mile Report Line	42
Start Levee Mile	4.96
End Levee Mile	4.96
Location	Water Side
Category	Earthen Levee
Item	Encroachments
View of equipment along the waterward side of the levee crown looking downstream.	
pkazi_f_20131001_264.jpg

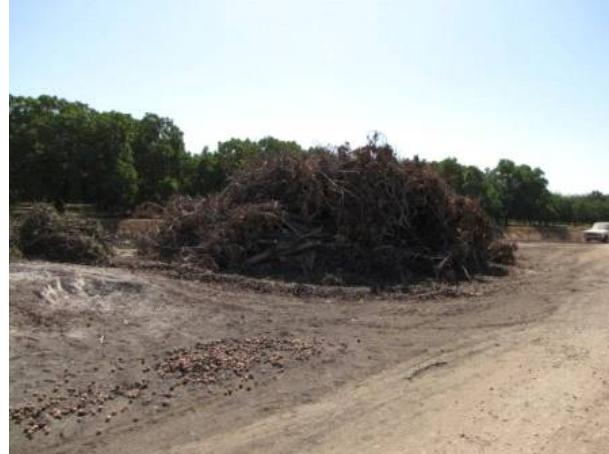
Levee Mile Report Line	43
Start Levee Mile	4.97
End Levee Mile	4.97
Location	Water Side
Category	Earthen Levee
Item	Encroachments
View of prunings pile along the waterward side of the crown looking downstream.	
pkazi_f_20131001_310.jpg

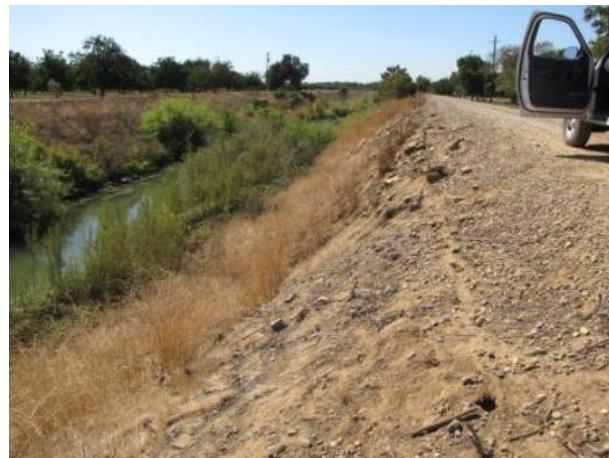
Levee Mile Report Line	44
Start Levee Mile	5.14
End Levee Mile	5.14
Location	Water Side
Category	Earthen Levee
Item	Slope Stability
View of a slip in the waterward levee slope looking downstream.	
pkazi_f_20131001_373.jpg

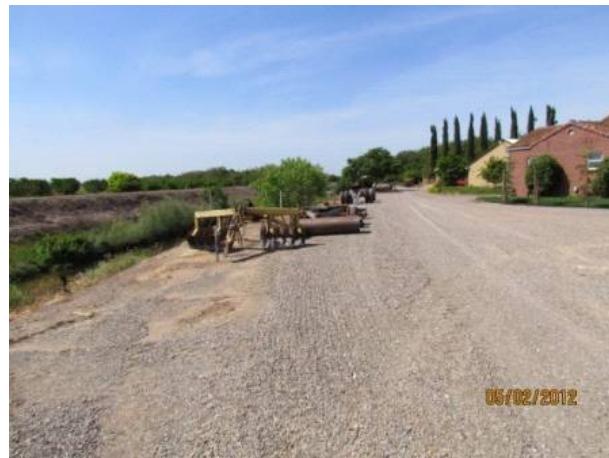
Levee Mile Report Line	48
Start Levee Mile	5.37
End Levee Mile	5.37
Location	Water Side
Category	Earthen Levee
Item	Encroachments
Equipment was found on the waterside of the levee looking downstream.	
pkazi_f_20131001_337.jpg

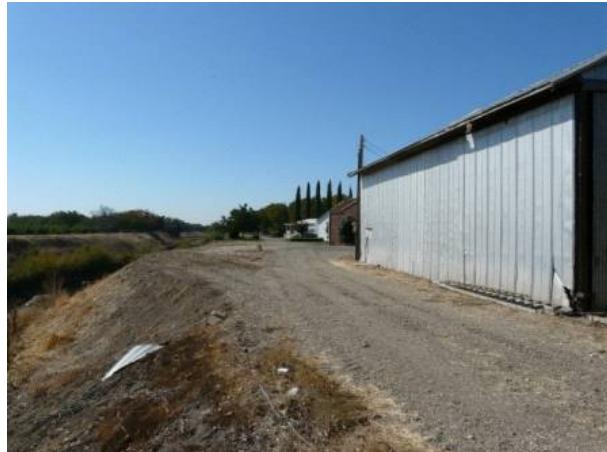
Levee Mile Report Line	49
Start Levee Mile	5.38
End Levee Mile	5.45
Location	Land Side
Category	Earthen Levee
Item	Encroachments
Building located immediately adjacent to access road approximately from LM 5.38 to 5.45	
pkazi_f_20131001_267.JPG

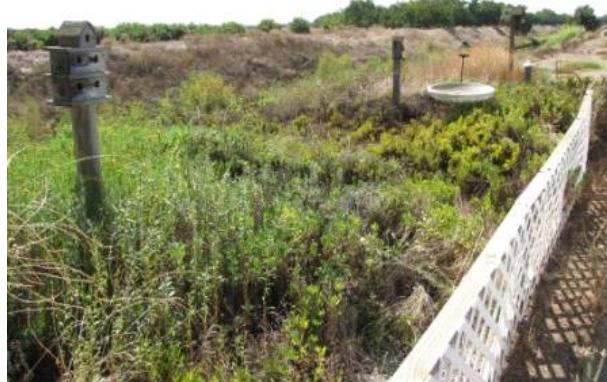
Levee Mile Report Line	50
Start Levee Mile	5.42
End Levee Mile	5.42
Location	Water Side
Category	Earthen Levee
Item	Vegetation
View of landscaping planted along the waterward side of the access road impacting visibility and the ability to floodfight looking downstream.	
pkazi_f_20131001_374.jpg

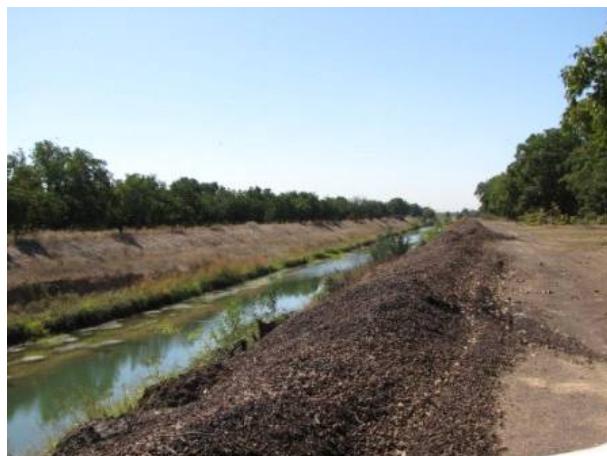
Levee Mile Report Line	51
Start Levee Mile	5.60
End Levee Mile	5.65
Location	Water Side
Category	Earthen Levee
Item	Encroachments
View of discarded nut shells placed along the waterward slope to be burned looking downstream.	
pkazi_f_20131001_375.jpg
